# IPS EMPRESS CROWN

*On The Maxillary Right Central Incisor*

by DOUGLAS A. TERRY, D.D.S.

The patient presented requesting esthetic improvement of the maxillary right central incisor (tooth #8). The ceramo-metal crown on the maxillary right central incisor was replaced with a leucite-reinforced, pressed glass ceramic crown (IPS Empress, Ivoclar), in order to achieve the proper gradient of translucency which would allow optimal integration and harmony with the adjacent dentition.

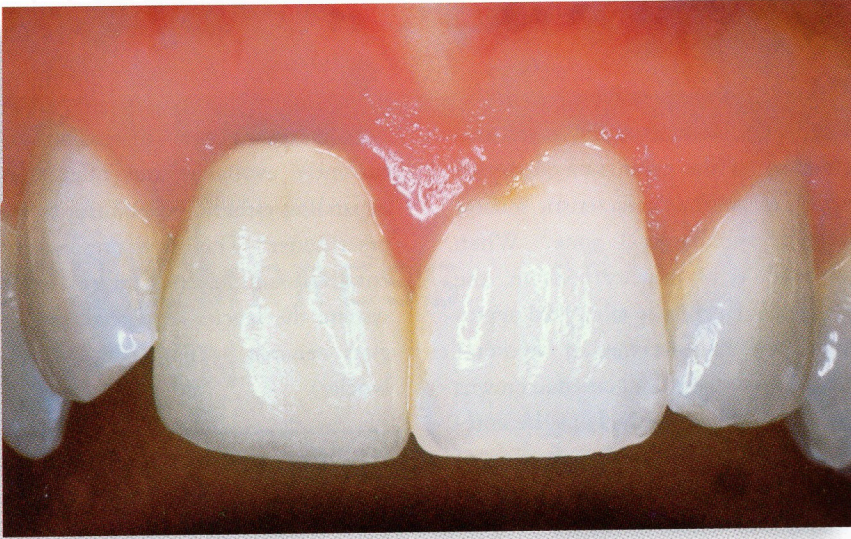
Figure 3: Pre-operative of maxillary arch.

The gingival tissue around the existing ceramo-metal crown on the maxillary right central incisor was enlarged and bluish to pink in color; the gingiva was not stippled. (Figure 3) The shape, contour, and shade of the incisor required restorative attention and esthetic enhancement.

The treatment plan was formulated and consisted of replacing the ceramo-metal crown on the maxillary right central incisor with a leucite-reinforced, pressed glass ceramic crown (IPS Empress, Ivoclar). The material was selected in order to achieve the proper gradient of translucency, which would allow optimal integration and harmony with the adjacent dentition.<sup>7,8</sup> Additionally, the plan included a complete resin bonding of the existing enamel defect at the gingival crest of the maxillary left central incisor tooth #9.

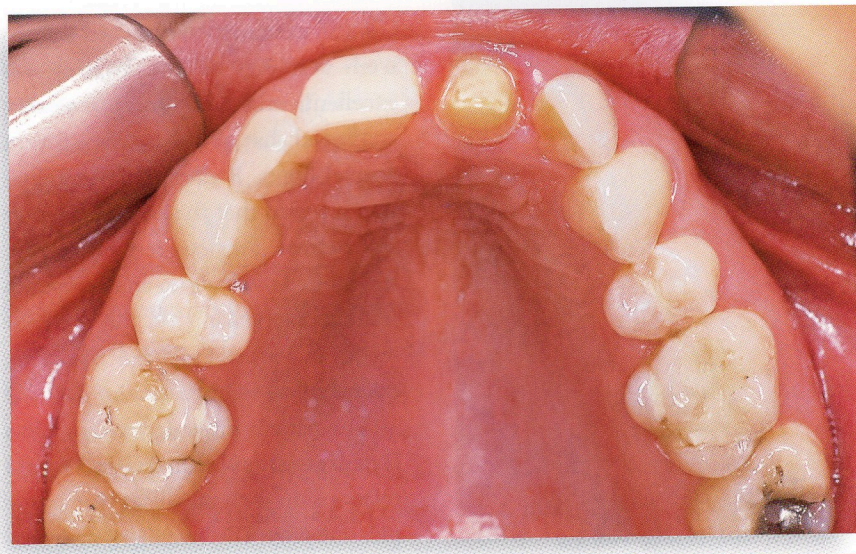
Figure 5: Crown Preparation.

All finish lines were inspected, and any sharp edges were refined as necessary. The gingival areas of the teeth were carefully cleansed with hydrogen peroxide, thoroughly rinsed, lightly dried, and examined. (Figure 5)

Anesthesia was administered, and the gingiva was retracted with nonmedicated retraction cord (#00 Ultrapack/Ultradent). A #1558 high-speed bur under Zeiss 4.5X magnification was used to remove the existing ceramo-metal crown. The area was debrided with hydrogen peroxide, and the tooth preparation was carefully inspected. The facial and lingual surfaces were reduced by approximately 1.5 mm, and all sharp edges and angles were rounded. The margins were located at the gingival crest or slightly into the sulcus. Following preparation, the teeth were carefully examined, debrided, and rinsed with hydrogen peroxide.

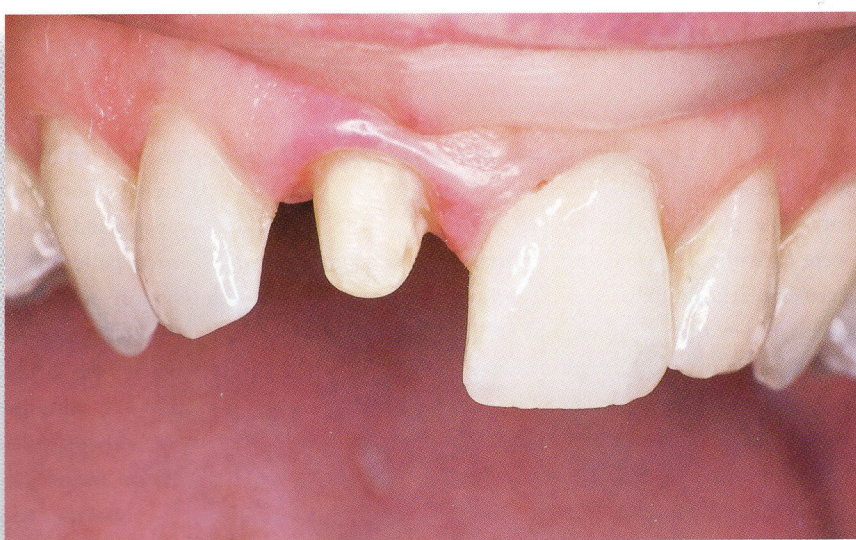
Figure 6: Evaluation of margins in relationship to the gingival crest.

On the appointment to seat the fabricated provisional restoration, local anesthesia was administered. The provisional restoration was removed, and the margins were evaluated in relationship to the gingival crest. (Figure 6) The preparation was re-packed with nonmedicated cord and allowed to remain in place for five minutes. The cord was then moistened and removed. The area was rinsed and lightly air dried. An impression was taken with a polyether impression material in a full arch tray. A standard injection wash technique was followed by placement of the tray material. The impression was rinsed, dried, and carefully inspected. Bite registrations were taken (Figure 7), and the new composite provisional restoration was luted with temporary eugenol-free cement. (Figure 8)

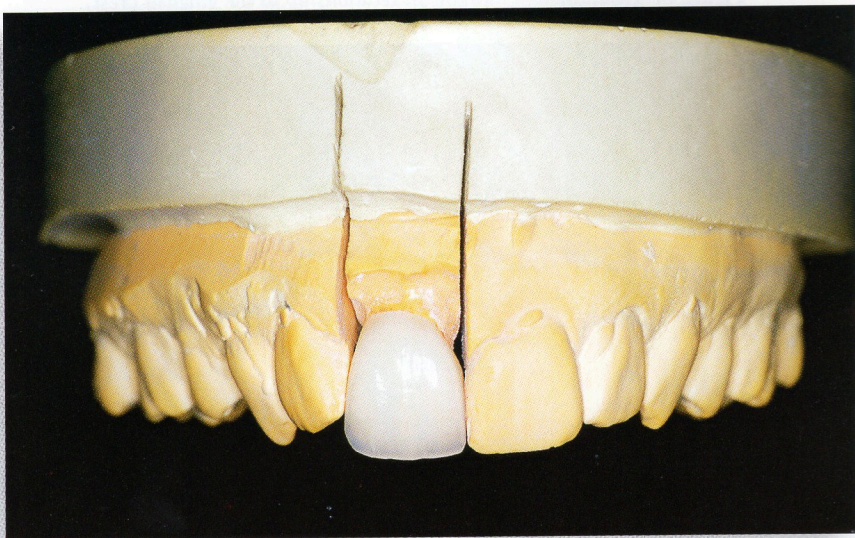
Figure 9: Inspection of crown on laboratory model.

A visual inspection of the crown was performed upon return from the laboratory. (Figure 9) The restoration was placed on a laboratory model to ensure complete seating and adequate contacts. The dimensions were observed, and the shape and contour were compared to the adjacent central incisor. The margins were inspected under surgical telescopes (Zeiss 4.5X magnification) and found to be precise. The internal surfaces of the crown were inspected for a uniform, frosted appearance. The shade was compared to the selected shade tabs and photographs, and the diagram was reviewed.

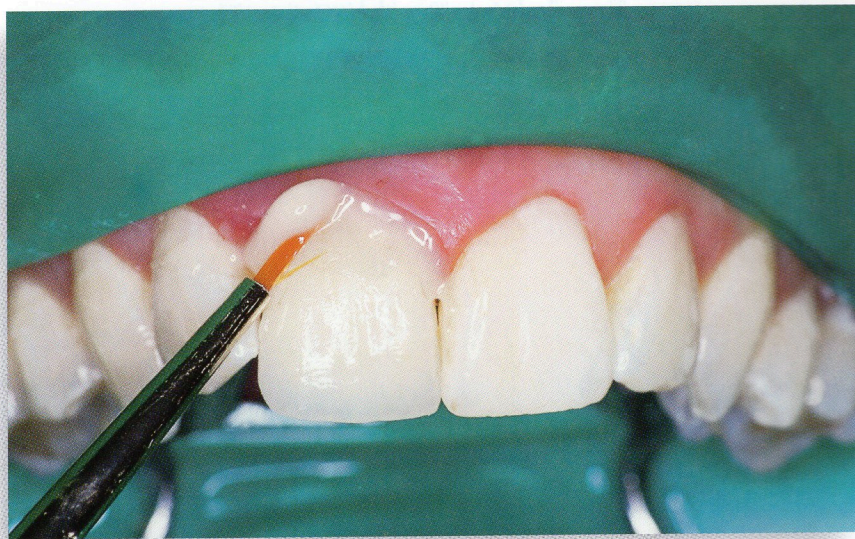
Figure 10: Removal of excess cement with sable brush.

The catalyst and base were mixed in equal amounts for 10 to 20 seconds, and an even coat was placed on the internal surface of the crown, including the margins. The restoration was gently seated, and the margins were evaluated with an explorer while holding firmly in place. The excess cement was removed by using a sable brush

(#000). (Figure 10) It is important to leave a residual amount at the margins to counteract any polymerization shrinkage of the cement.<sup>9</sup> Once the position of the crown was satisfactory, the crown was spot cured in the center of the facial surface for 20 to 30 seconds using a small (2 mm to 3 mm) light curing tip. A thin layer of glycerin was applied to the margins to prevent formation of an air inhibited layer. The crown was cured for two minutes with two Optilux curing lights with large diameter tips. Excess resin was removed with Bard Parker blades (#s 12 & 15).

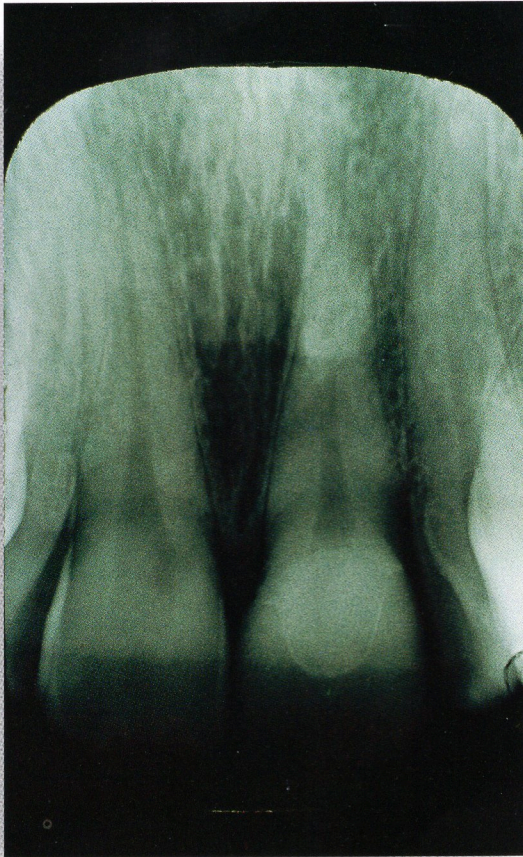
Figure 11: Post-operative radiograph.

The final polishing was achieved with rubber porcelain polishing wheels, cups, and diamond polishing paste (Vident). The interproximal and cervical areas were evaluated with dental floss to ensure adequate contact and the absence of gingival overhangs. A post-operative radiograph (Figure 11) verified the absence of gingival overhangs. The occlusion was evaluated by having the patient close gently and without force. Finishing diamonds were used to

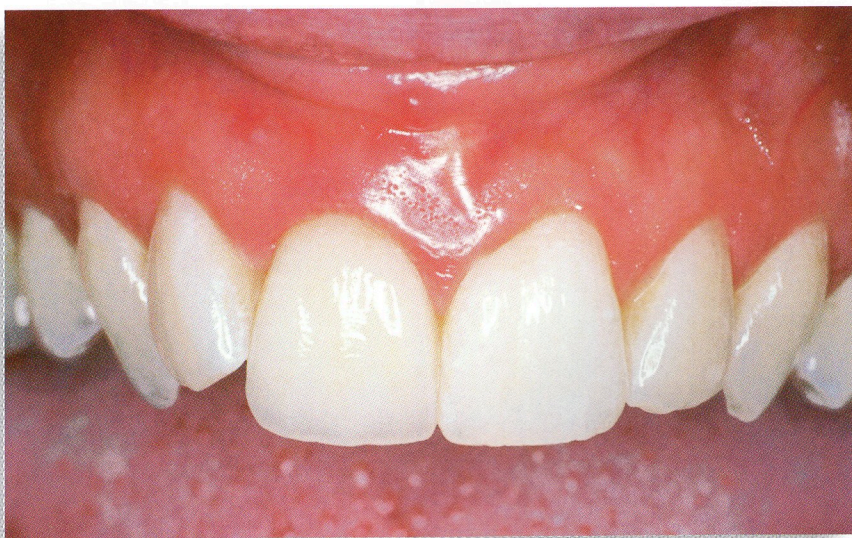
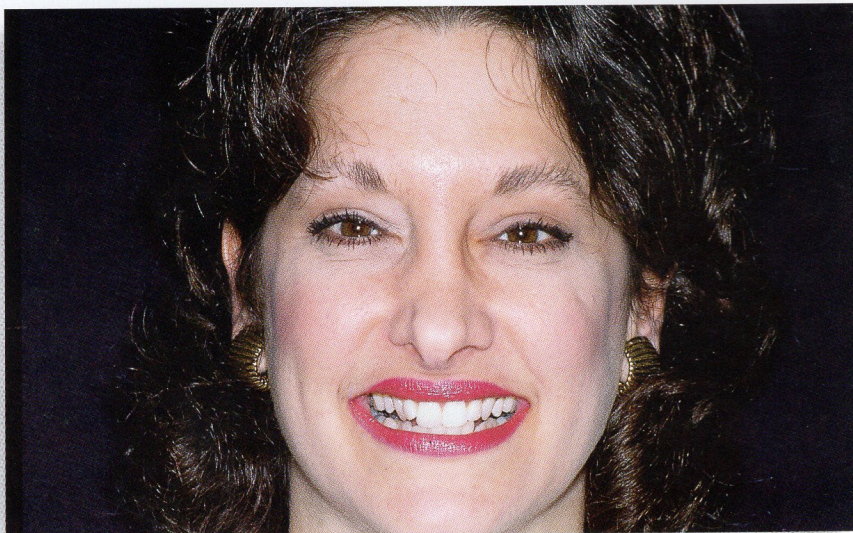
Figure 12: Post-operative of maxillary arch.

In 1956, Frush and Fisher compared an optimal smile with a stage, where the two dominant actors are played by the central incisors and where the lateral incisors must not antagonize them in any way.<sup>11</sup> This presentation exemplifies the esthetic results that can be accomplished when there is communication and understanding between the ceramist, the dentist, and the patient. Through utilization of the all-ceramic system and proper operative procedures, a natural appearance revealing a satisfactory integration with the surrounding tissues was reinstated for the patient.<sup>12</sup> (Figures 12 & 13) *AB*

Figure 13: Post-operative of full face.
